Current Concepts of Shoulder Arthroplasty for Radiologists: Part 2—Anatomic and Reverse Total Shoulder Replacement and Nonprosthetic Resurfacing

OBJECTIVE. The purpose of this article is to provide a review of the indications for shoulder arthroplasty, describe preoperative imaging assessment, present new and modified designs of shoulder arthroplasty, illustrate normal and abnormal postoperative imaging findings, and review key radiographic measurements.

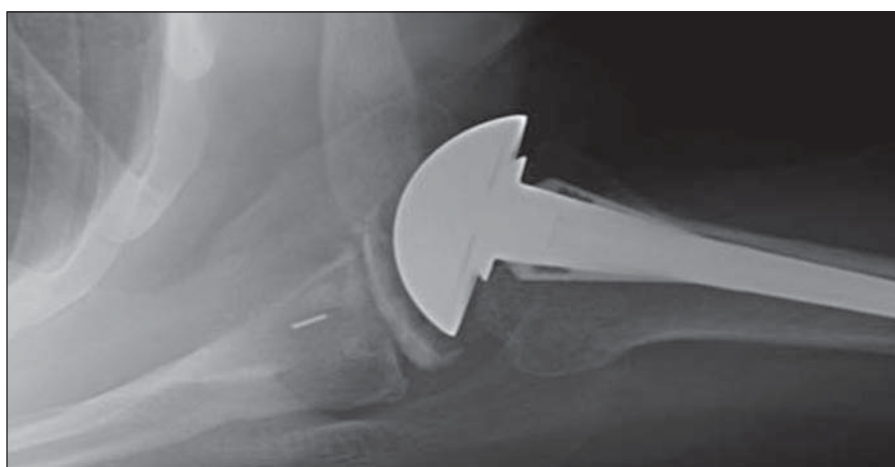
Fig. 2—Glenoid component loosening in 72-year-old woman with anatomic total shoulder arthroplasty. **A** and **B**, Grashey (**A**) and axial (**B**) radiographs show frank loosening of glenoid component, with several millimeters of space between bone and polyethylene face (*arrow, A*). (Fig. 2 continues on next page)

The most common complication of anatomic total shoulder arthroplasty is loosening of the glenoid component, occurring in up to 39% of patients [5] (Figs. 2 and 3). Radiolucency at the bone-cement interface of the glenoid component is present in 30–96% of cases. Pegged radiolucency is described by the Lazarus et al. [6] classification (Fig. 4A) and keeled radiolucency by Franklin et al. [7] (Fig. 4B). A recent trend is use of a minimally cemented glenoid component with radial fins on the central peg that are packed with bone graft for biologic incorporation [8, 9]. Lower radiolucency scores

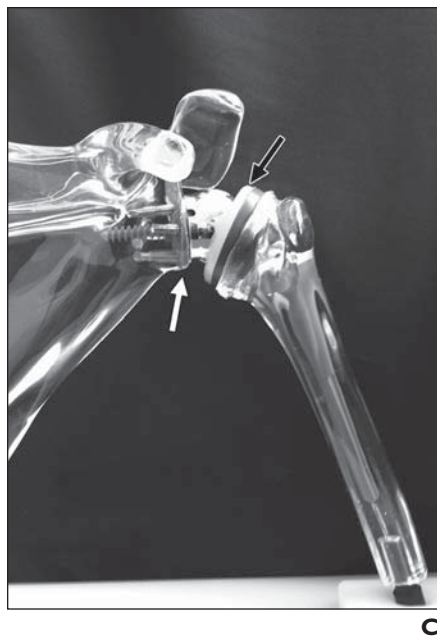
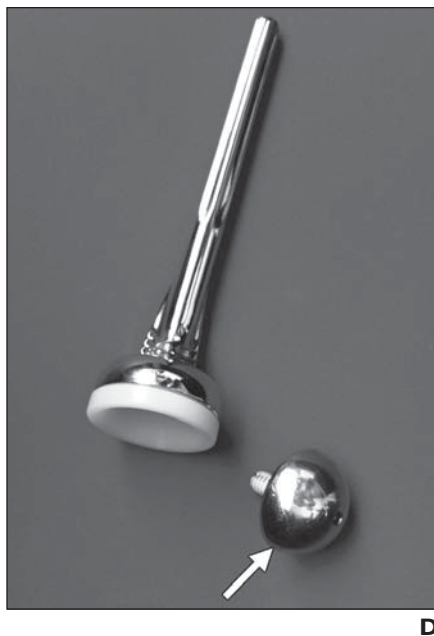
Fig. 5 (continued)—Reverse total shoulder arthroplasty in 76-year-old woman.
C, Photograph of reverse total shoulder arthroplasty model shows metaglene (*white arrow*) that inserts into glenoid. Polyethylene liner (*black arrow*) is seen between humeral stem and glenosphere ball.
D, Photograph of separated components of reverse total shoulder arthroplasty shows metal humeral stem and white polyethylene liner that articulates with round glenosphere (*arrow*).

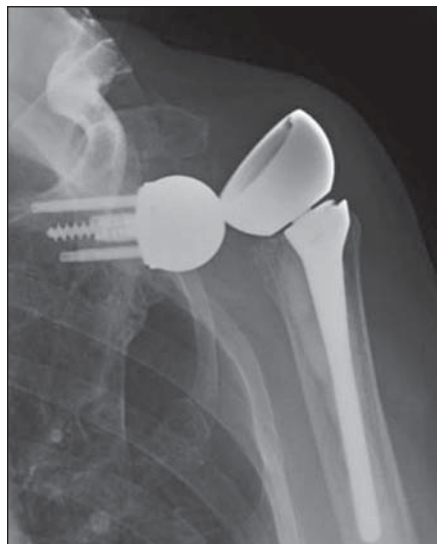
Fig. 6—Reverse total shoulder arthroplasty dislocation in 74-year-old woman. Anteroposterior radiograph shows anterior dislocation of humeral component of reverse total shoulder arthroplasty with humerus anterosuperior rather than anteroinferior. This is due to pull of deltoid muscle. This is most common immediate complication, with incidence of 20%.

Anterior dislocation is the most common early postoperative clinically significant complication, occurring in up to 20% of patients [14] (Fig. 6). The humeral component dislocates in the anterior-superior direction due to pull of the deltoid muscle, a difference from a native shoulder dislocation wherein the humerus lies inferior to the coracoid process [14]. In the immediate postoperative period, hematomas may be seen in up to 21% of patients.
