Cervical Spine Trauma: Pearls and Pitfalls

Mark P. Bernstein¹, Alexander B. Baxter

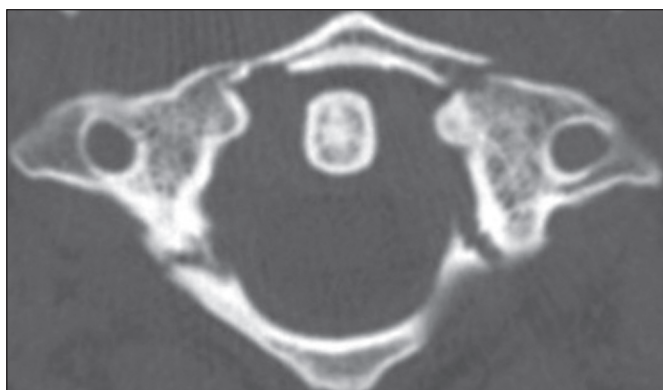
Fig. 1—38-year-old man with classic Jefferson burst fracture with two anterior and two posterior ring fractures.

The classic Jefferson fracture (Fig. 1) is a four-part fracture, with fractures occurring at the weakest points of the ring, the anterior and posterior junctions of the arches and lateral masses. It is a decompressive injury with radial displacement of the fragments away from the spinal canal. As an isolated injury, the classic Jefferson burst is both mechanically and neurologically stable.

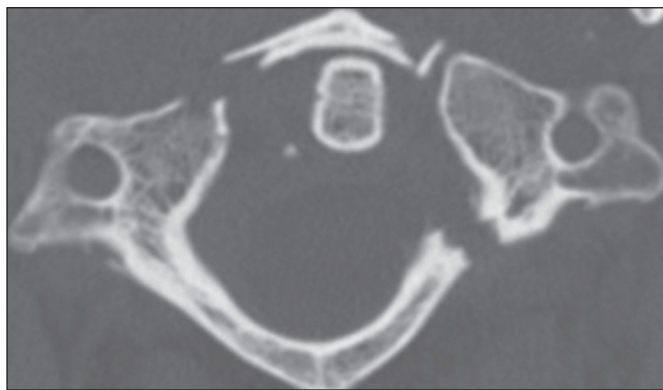
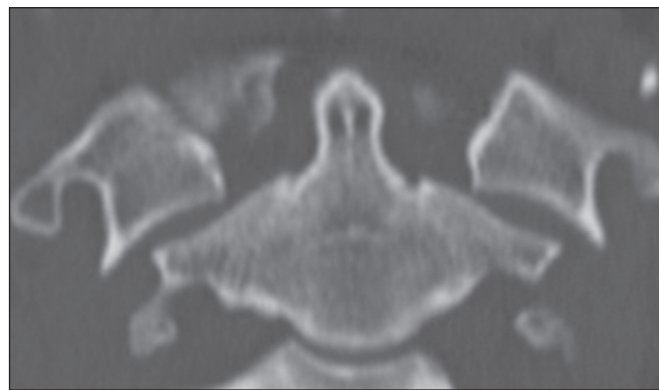
Fig. 2—32-year-old woman with variant Jefferson burst fracture. **A** and **B**, Transaxial (**A**) and coronal (**B**) CT reformations show lateral spread of fracture fragments, which indicates transverse ligament rupture and instability. (Reprinted with permission from [1])

Atypical Jefferson fractures (Fig. 2) are produced by asymmetric axial loading, resulting in fewer than four fractures of the C1 ring. Transverse ligament injury allows the ring to open and renders the Jefferson variants unstable, permitting C1–2 subluxation. Consequently, the integrity of the transverse ligament must be assessed to determine stability.

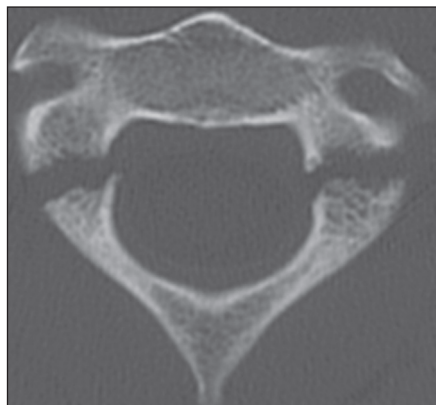
Fig. 3—24-year-old man with hangman's fracture. Bilateral C2 pars interarticularis fractures are seen. (Reprinted with permission from [1])

The "hangman's fracture," or traumatic spondylolisthesis of C2 (Fig. 3), refers to bilateral pars interarticularis fractures, which bear similarities to findings seen in persons who have undergone judicial hanging. Most of these fractures result from falls and motor vehicle crashes, and the fractures reflect a variety of injury mechanisms.

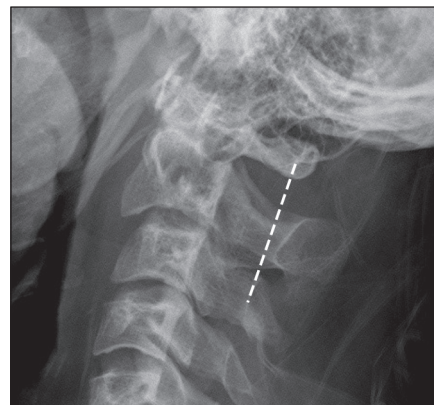
Fig. 4—28-year-old man with atypical hangman's fracture. C2 body fracture with anteroposterior displacement of fracture fragments (fat C2 body sign) is seen. Fracture disrupts Harris ring posteriorly and causes posterior offset of spinolaminar line from C1 to C3 (dotted line).

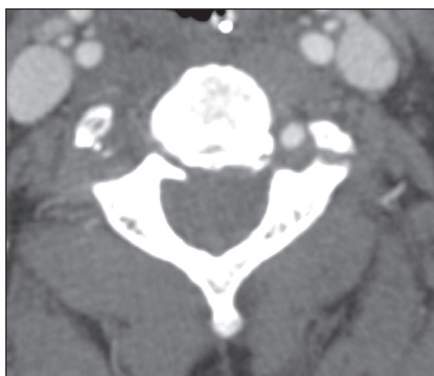
Fig. 5—55-year-old man with atypical hangman's fracture. Transaxial CT angiography image shows fractures through both transverse foramina, with occlusion of right vertebral artery.

Type 1 fractures are radiographically subtle and may be easily overlooked but should be identified on CT with multiplanar reconstructions. Prevertebral soft-tissue swelling is often present, and the spinolaminar line from C1 to C3 may show posterior displacement of the C2 spinolaminar junction. Atypical fractures disrupt the Harris ring posteriorly and show anteroposterior separation of C2 body fracture fragments, known as the fat C2 sign (Fig. 4). Fractures involving the transverse foramen, or those associated with neurologic deficit, should be followed with angiographic imaging, usually CT angiography, to exclude vertebral artery injury (Fig. 5).

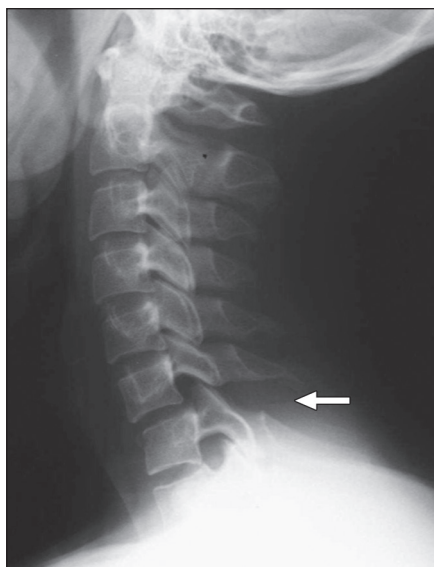
Fig. 6—21-year-old woman with anterior subluxation. Lateral cervical spine radiograph shows subtle signs of hyperflexion, including C6-7 interspinous widening (arrow), uncovering of facets, and slight anterior translation. Courtesy of Rybak L, NYU Langone Medical Center, New York, NY.

Subaxial hyperflexion injuries (Fig. 6) comprise progressively severe disruptions of cervical ligamentous integrity. These range from hyperflexion sprain, to anterior subluxation, to bilateral interfacetal dislocation and flexion teardrop fracture. Corresponding ligamentous disruption progresses from posterior to anterior, beginning with disruption of the supraspinous ligament, interspinous ligaments, capsular ligaments, and ligamentum flavum. This group of ligaments is referred to as the posterior ligament complex.

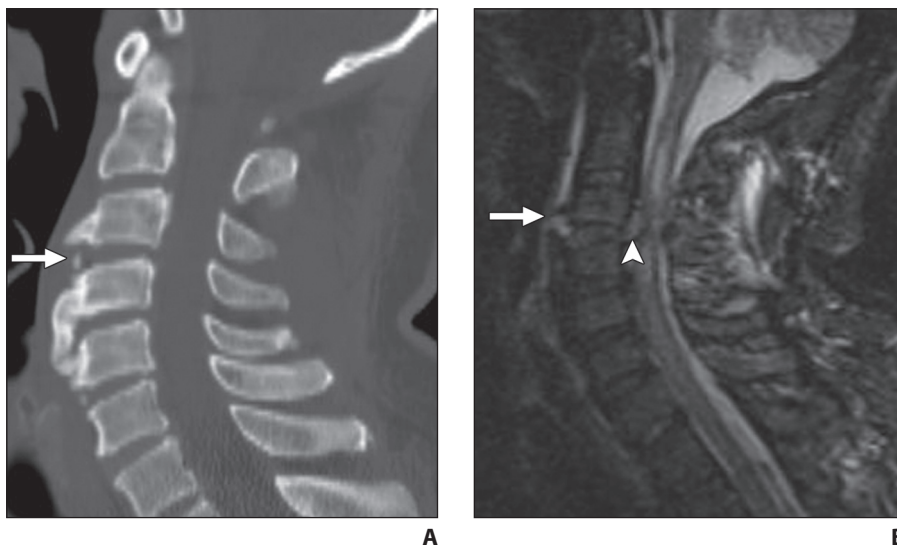
Fig. 7—64-year-old man with hyperextension-dislocation.

A, Midsagittal CT image shows slight anterior disc space widening at C3–4 and osteophyte chip fracture (*arrow*). Spinal column is otherwise well aligned.

B, Midsagittal T2-weighted MRI shows prevertebral soft-tissue edema with disruption of anterior longitudinal ligament (*arrow*). Contused spinal cord is squeezed between traumatic disc herniation (*arrowhead*) and ligamentum flavum. Posterior soft-tissue injury is indicated by high signal changes. (Reprinted with permission from [1])

Hyperextension-dislocation injuries usually involve the lower cervical spine. Signs on lateral radiographs and sagittal CT reformations include mild anterior intervertebral disk space widening, anterior vertebral body avulsion fragments, and facet malalignment (Fig. 7A). In the normal spine, facets should be parallel. With extension injuries, one may see V-shaped facet joints that are wide anteriorly and tapered posteriorly.

MRI reveals the extent of discoligamentous injury. T2-weighted images show ligamentous disruption, soft-tissue edema, disk protrusion, and spinal cord injuries (Fig. 7B).

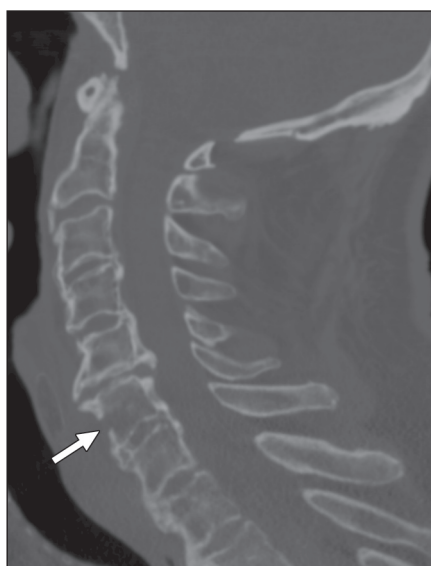
Fig. 8—69-year-old man with fused spine hyperextension fracture with cortical disruption of C6 (*arrow*). Transverse fracture orientation is easily overlooked on transaxial CT.

Sagittal CT reformations optimally identify undisplaced subtle fractures because they are often horizontal, limiting the utility of transaxial images (Fig. 8). Fractures may involve the vertebral body, the fused disk space, or traverse both in an oblique fashion. These fractures typically involve the lower cervical spine and are complete, crossing all ossified ligaments from anterior to posterior and resulting in marked instability.
