Imaging of Hip Arthroplasty

Theodore T. Miller, M.D.¹

ABSTRACT

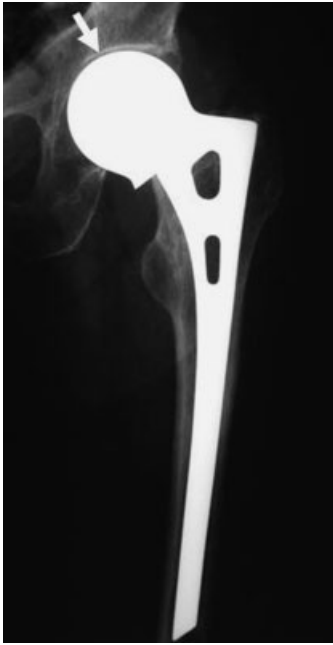
Figure 1 AP radiograph of a Moore unipolar prosthesis. The prosthetic femoral head articulates directly against the native acetabular cartilage, causing cartilage narrowing (arrow).

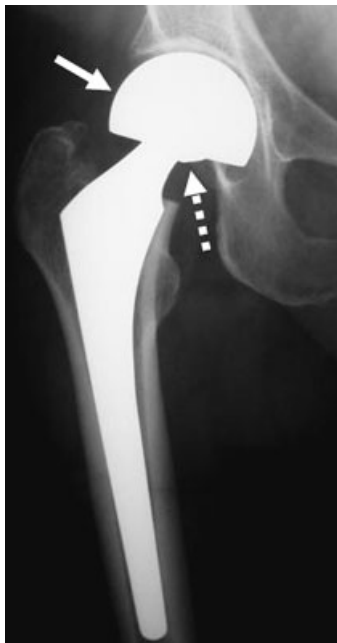
Figure 2 AP radiograph of a bipolar hemiarthroplasty shows the acetabular cup (solid arrow), which is placed into the native socket but is not fixed to it. The inferior aspect of the prosthetic femoral head (dashed arrow) is just barely visualized.

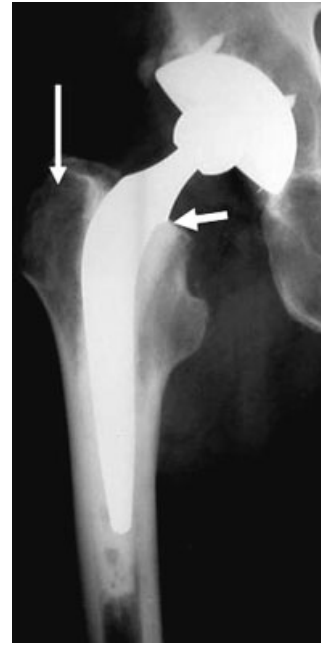
Figure 3 AP radiograph of a normal-appearing total hip replacement. The femoral stem is cemented; the tip of the femoral stem is in mild valgus position, the cement column fills the medullary cavity well, and the flange of the prosthesis is flush against the cut surface of the femoral shaft (short arrow) indicating that no subsidence has occurred. Lucency is present in the greater trochanter (long arrow) because of stress shielding. Notice that the acetabular cup is fixed to the acetabular socket by screws and that it is inclined correctly at ~ 45 degrees.

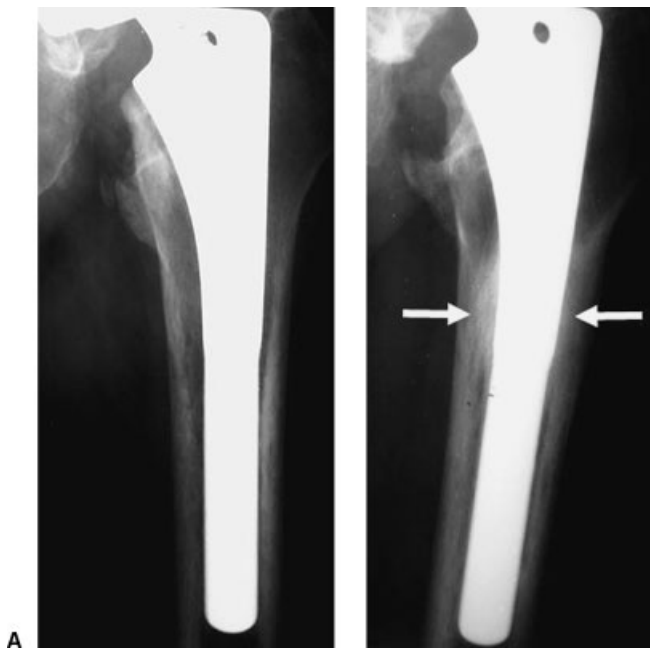
Figure 4 Ingrowth femoral component. (A) Initial post-operative radiograph shows lucency around the proximal aspect of the femoral stem. Porous coating is present along the proximal half of this particular stem. (B) AP radiograph approximately 2 years later shows ingrowth of bone (arrows) onto the stem.

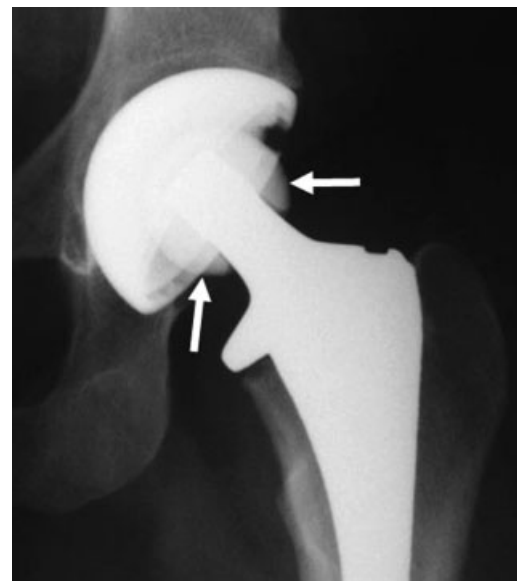
Figure 5 AP radiograph of a ceramic femoral head. The head (arrows) is less dense than the adjacent metal components. The cylindrical taper to which the head is attached can be seen through the less dense head.

10 to 20 degrees.¹⁰ The prosthetic head should be symmetrically seated within the cup, appearing on a frontal radiograph as being equidistant from the superior and inferior margins of the cup (Fig. 3). If the type of PE liner implanted by the surgeon has a thicker superior rim (called an "offset" liner), the head may be slightly inferiorly located in the cup, but a head located superiorly in the cup, even mildly so, is never normal and indicates PE wear. Most femoral heads are made of some type of metal and are thus radiographically dense; ceramic heads, used in an attempt to decrease PE wear (see later), are less radiodense (Fig. 5).

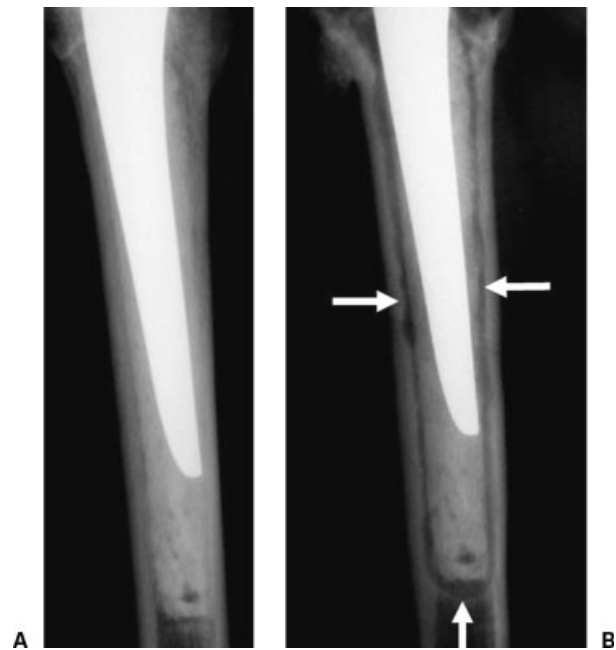
Figure 6 Progressive lucency due to loosening. (A) Initial AP radiograph shows a cemented stem in mild valgus position. A thin radiolucency is present at the cement bone interface laterally and proximal-medially because of the normal fibrous capsule that forms due to the curing of the cement. (B) AP radiograph ~2 years later shows the development of radiolucency (arrows) around the entire cement mantle. The lucency is irregular and focally wide, particularly at the tip.

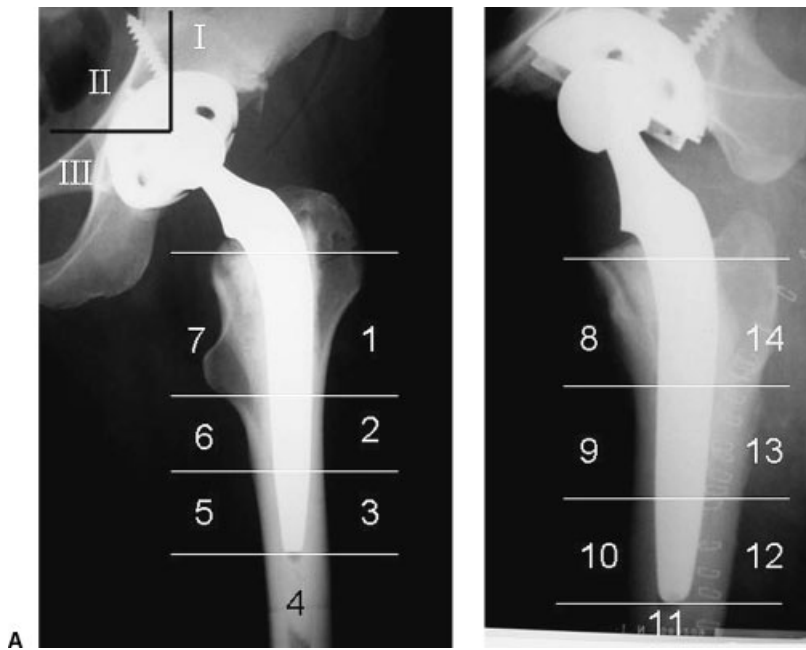
Figure 7 Femoral zones and acetabular zones. (A) AP radiograph shows the seven femoral zones and the three acetabular zones. (B) True lateral radiograph shows the additional seven femoral zones.

The description of the location of the lucencies should follow the standard orthopedic descriptions of femoral and acetabular "zones" (Fig. 7): there are seven

femoral zones on the anteroposterior (AP) radiograph, with the first three numbered from proximal to distal along the lateral aspect of the stem, zone 4 at the tip of the stem, and zones 5 to 7 numbered from distal to proximal along the medial aspect of the stem.⁸ There are an additional seven zones on the lateral radiograph, numbered 8 through 14, beginning at the anteroproximal aspect of the femoral stem. The region around the acetabular component is divided into three equal zones, I, II, III, from lateral to medial around the periphery of the cup.²¹

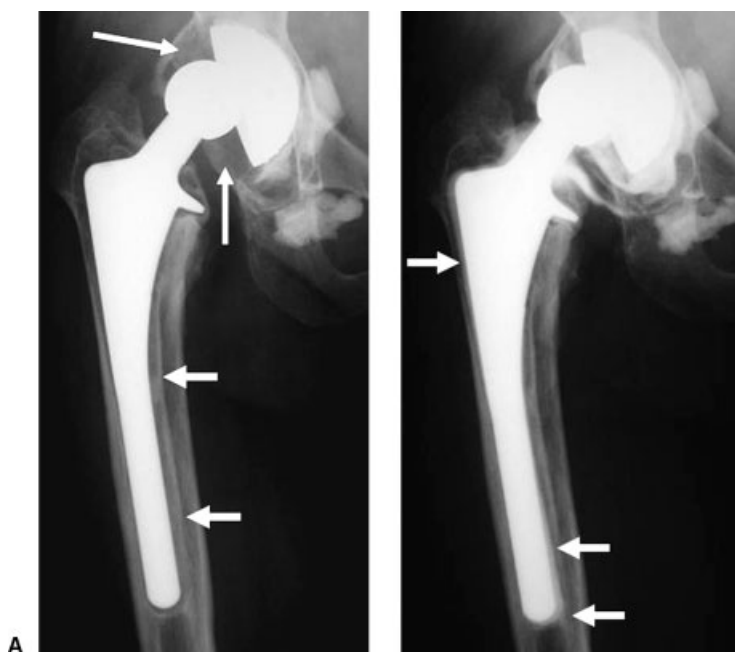
Figure 8 Loosening. (A) AP radiograph shows lucency around the metal bone interface with a sclerotic rim of demarcation (short arrows). Lucency related to osteolysis is also present in the acetabulum (long arrows), and the cemented acetabular cup has become vertically inclined because of loosening. Radiodense cement is present along the medial and inferior aspects of the pelvis. (B) Corresponding AP arthrographic image shows contrast insinuating itself along the metal bone interface (arrows). Contrast did not convincingly insinuate around the acetabular component.

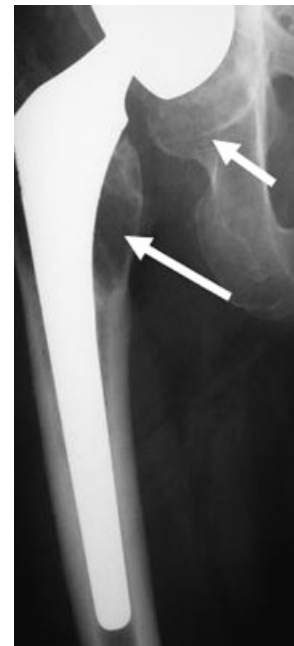
Figure 9 AP radiograph shows a well-defined focus of osteolysis in zone 7 of the femoral component (long arrow). A more subtle area of osteolysis is present in zone 3 of the acetabular component (short arrow).

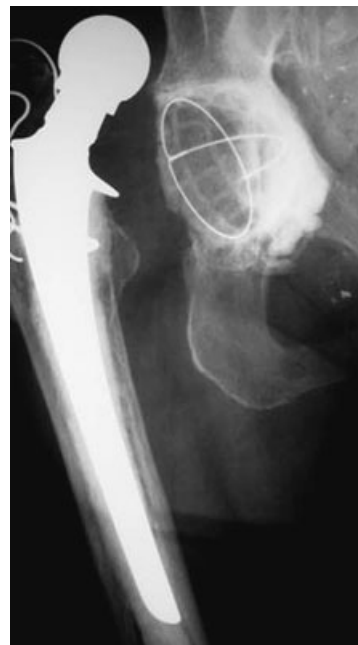
Figure 10 AP radiograph of a dislocated total hip replacement shows a vertically inclined acetabular component.

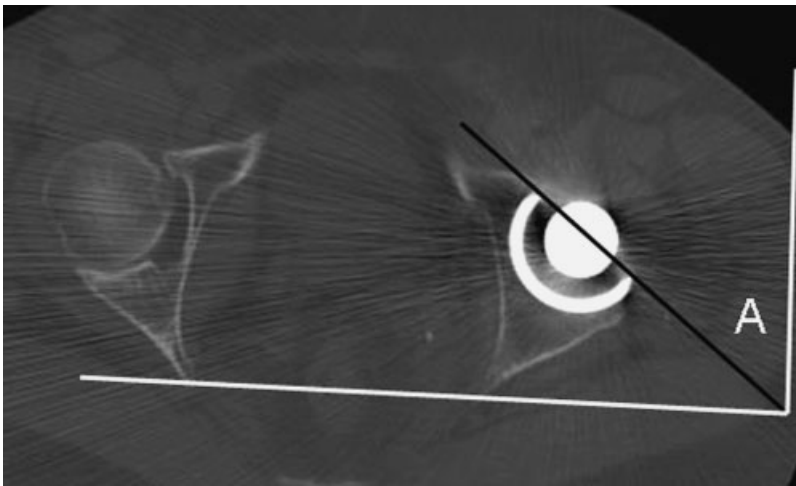
Figure 11 CT image through the acetabulum of a patient with recurrent anterior dislocations. The angle of acetabular anteversion (A) is measured by drawing a line tangential to the opening of the acetabulum and measuring it compared with a line in the AP plane of the patient (short white line). Because the patient may be lying slightly rotated on the CT table, a line should be drawn tangential to the posterior aspects of the posterior columns (long white line) to find the correct AP line against which to measure the acetabular version.

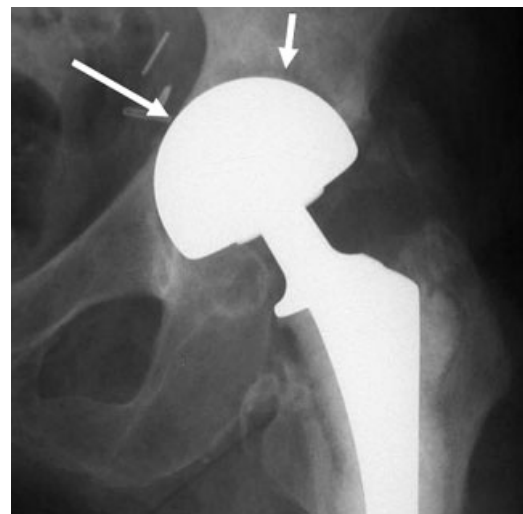
Figure 12 AP radiograph of a patient with a painful septic hip shows ill-defined lucency around zone 1 of the acetabular cup (short arrow) and frank perforation of the cup through the medial wall of the acetabulum (long arrow).

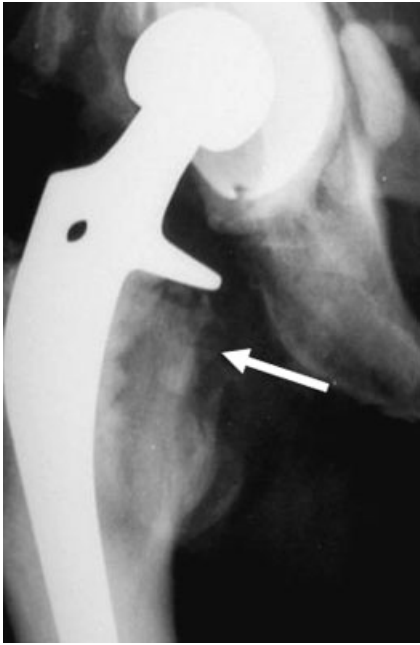
Figure 13 AP radiograph of a patient with a septic hip shows destruction of the femur in zone 7 (arrow).

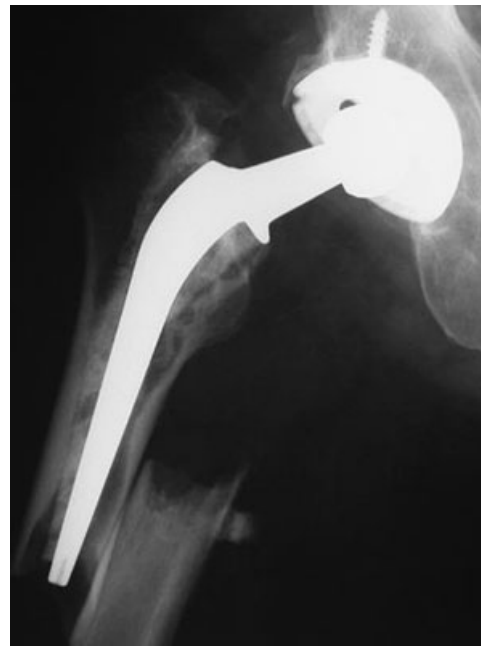
Figure 15 AP radiograph shows a fracture of the femur at the tip of the femoral stem with overriding of the fracture fragments. Irregular lucency is also present around the cement-bone interface at the distal aspect of the stem, which probably contributed to the stress riser effect.

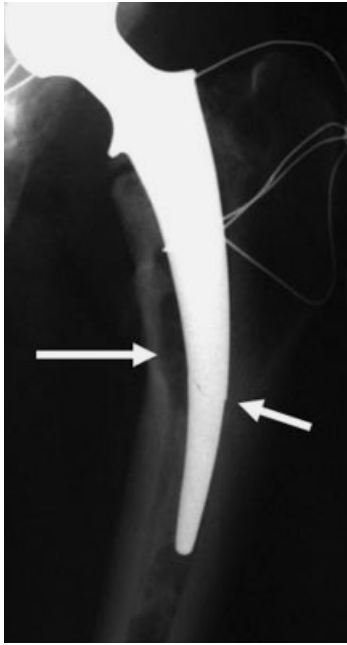
Figure 16 AP radiograph shows a subtle fracture through the femoral stem (short arrow). Well-defined osteolysis is present in zone 6 (long arrow), which probably contributed to the development of this stem fracture.

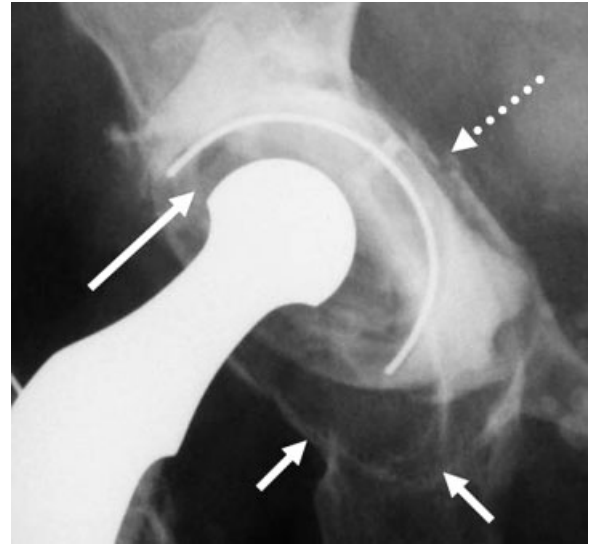
Figure 17 AP radiograph shows wear of the superior aspect of the polyethylene liner (long arrow) manifest as superior migration of the femoral head. Osteolysis is present around the acetabulum manifest as ballooning of the iliopubic line (dotted arrow) and by lucency around the inferior aspect of the acetabulum (short arrows).

asymmetric superior location of the femoral head within the acetabular cup, constituting type I wear (Table 3) (Fig. 17). Serial radiographs are necessary to detect subtle change, and care must be taken to make sure that the patient's positioning and beam alignment are the same from one examination to the next. Ebrahimzadeh et al showed that manual measurement of clinical radiographs is accurate for the assessment of wear,¹⁰¹ and Sychterz et al found that the single AP view was good enough to assess femoral head position as an indicator of PE wear in 95% of people, the other 5% needing a lateral

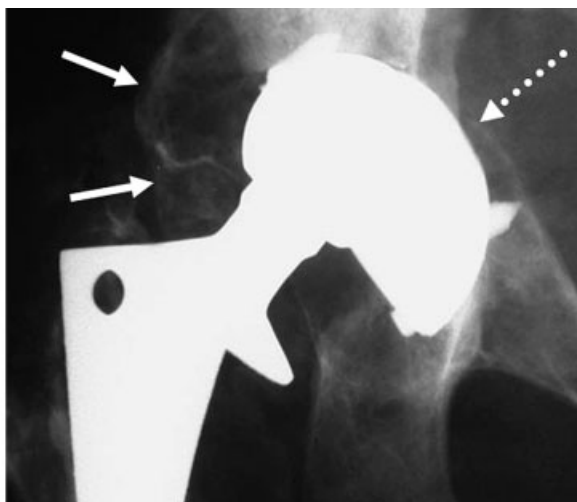
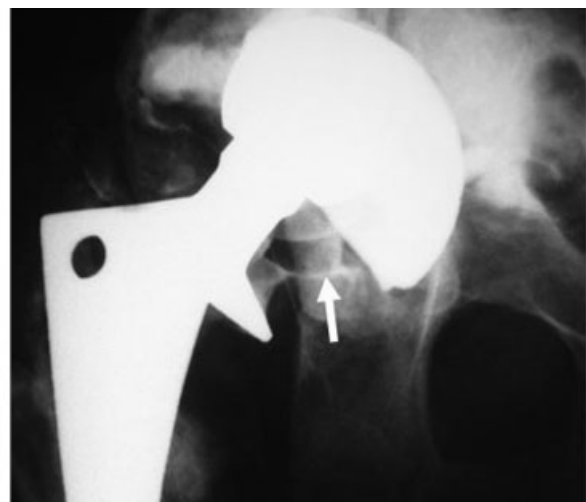
Figure 18 Breakage and displacement of the polyethylene liner: (A) AP radiograph shows the metal femoral head superiorly located in the metal acetabular cup. Severe osteolysis is present manifest by lucency along the lateral aspect of the acetabulum (solid arrows) and by destruction of the medial wall in zone 2 (dotted arrow). (B) AP arthrographic image shows a crescentic piece of a lucent polyethylene (arrow) outlined by contrast and floating freely in the joint space.

In addition to gradual wear, the PE liner can frankly break and dissociate from the metal acetabular shell. In this scenario, the femoral head is superiorly seated against the acetabular shell, and displaced pieces of the lucent PE liner and possibly displaced broken metal tines are seen on radiographs.^{37,105–107} The broken pieces of the liner can also be visualized arthrographically as lucent filling defects within the contrast pool (Fig. 18). Su et al reported a case of PE liner breakage resulting in articulation of the metal femoral head against the metal acetabular cup, causing marked metal debris (“metallosis”) that distended the hip capsule, appearing radiographically as a dense “bubble” around the joint.¹⁰⁸

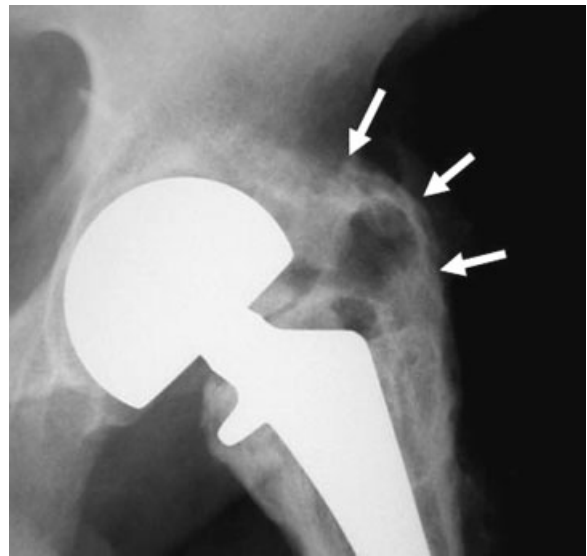
Figure 19 AP radiograph in a patient with a bipolar hemiarthroplasty shows Brooker type IV heterotopic ossification (arrows) that bridges the acetabulum and the femur.

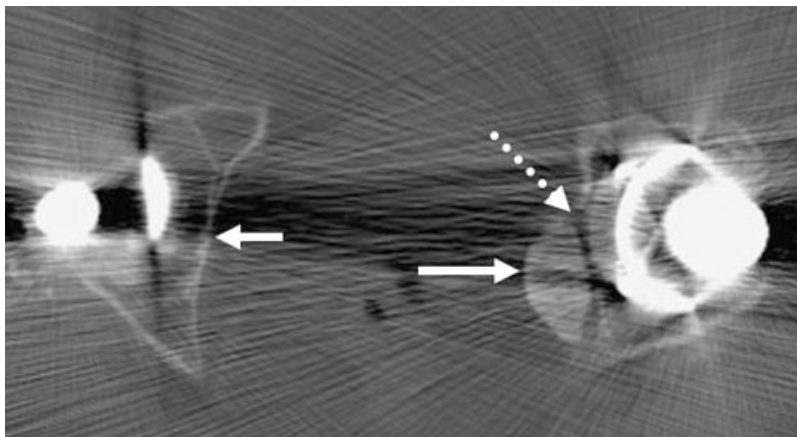
Figure 20 CT image through the acetabuli in a patient with bilateral hip replacements shows preservation of bone stock and the medial wall of the right acetabulum (short arrow). In the left hip there has been extrusion of cement (long solid arrow) through a defect of the medial wall of the acetabulum (dotted arrow). These findings are well seen despite the marked beam-hardening streak artifact.

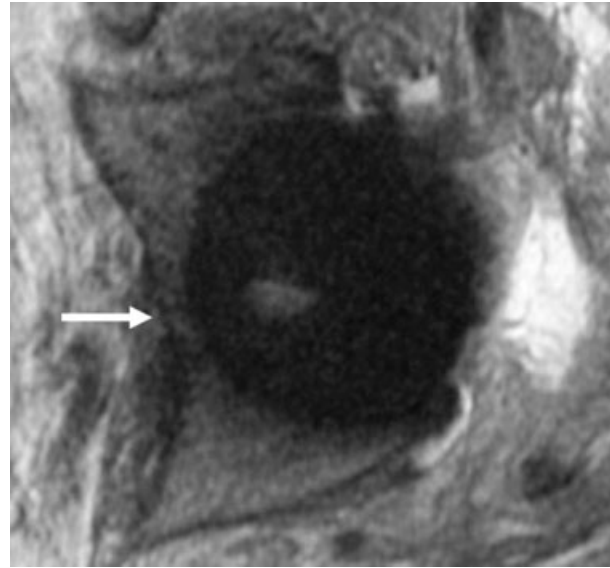
Figure 21 Axial proton density image on a 1.5T scanner through the acetabulum of a patient with a total hip replacement shows dephasing artifact around the acetabular cup itself but the surrounding bone and medial wall of the acetabulum (arrow) are still well visualized.

MR imaging, specifically tailored to reduce metal artifact, can depict the periprosthetic tissue on both high-field-strength^{125,126} and low-field-strength magnets¹²⁷ (Fig. 21). The appearance of periprosthetic soft tissue masses related to histiocytic osteolysis is variable; Potter et al described intermediate signal intensity collections with low-signal-intensity rims on T2-weighted images,¹²⁶ and White et al described low-signal-intensity collections on T1-weighted sequences that were heterogeneously low to intermediate signal intensity on T2-weighted images.¹²⁵ Infected collections have a signal intensity more similar to that of fluid,¹²⁶ with

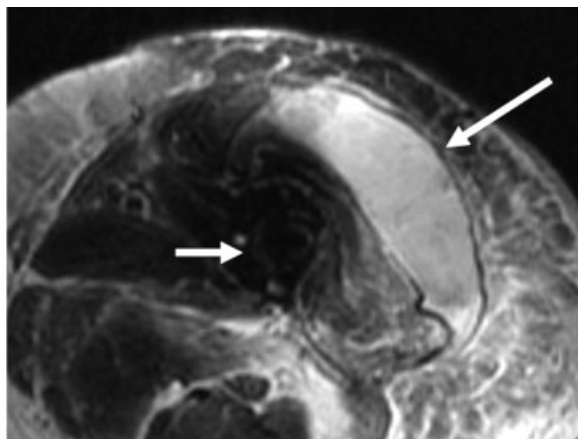
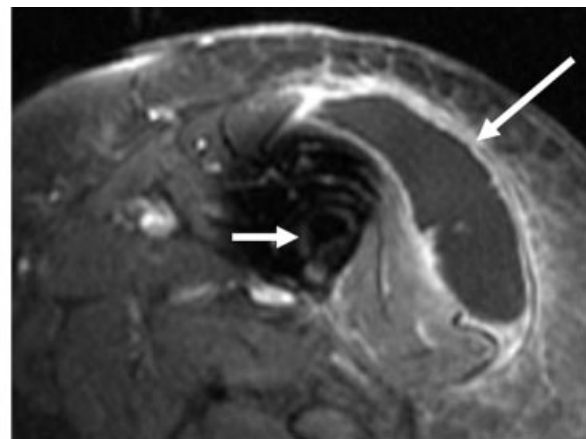
Figure 22 Periprosthetic abscess using a 1.5T scanner: (A) Axial fat-suppressed T2-weighted image through the thigh at the level of the prosthetic femoral stem shows signal void due to the stem (short arrow) with surrounding dephasing artifact, but the high-signal-intensity abscess in the lateral soft tissues is well seen (long arrow). (B) Corresponding axial fat-suppressed T1-weighted image after the intravenous administration of gadolinium contrast material shows the low-signal-intensity abscess with the brightly enhancing rim (long arrow). The signal void from the prosthetic stem (arrow) and surrounding dephasing artifact does not affect the appearance of the abscess.

contrast-enhancing rims¹²⁵ (Fig. 22). Other causes of pain after THA detected with MR imaging include avulsion of the abductor muscles from the greater trochanter¹²⁸ and fracture of the femoral stem.¹²⁹ Using a 0.5 T magnet to evaluate the femoral stem, Sugimoto et al reported that high signal intensity surrounding the stem on short inversion time inversion recovery (STIR) images, either with or without contrast enhancement, indicated loosening or a histiocytic response, and low signal intensity correlated with a normal radiographic appearance and a stable stem.¹²⁷
