MR Imaging Findings in Spinal Ligamentous Injury

Philip F. Benedetti¹, Linda M. Fahr², Lawrence R. Kuhns³, L. Anne Hayman^{2,4,5}

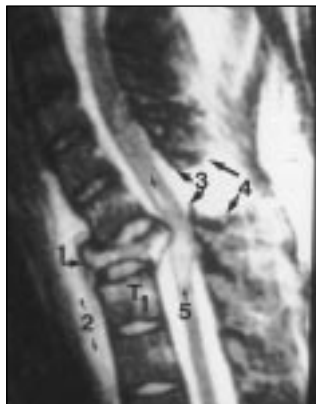
Fig. 7.—Burst fracture of C7 in 30-year-old woman who was unrestrained driver in motor vehicle crash. Sagittal fast spin-echo inversion-recovery MR image (TR/TE, 3000/51; inversion time, 140 msec) obtained on 1.5-T MR scanner shows burst fracture of C7 (1), prevertebral edema or hemorrhage (2), flaval (3) and interspinous ligament tears (4), with associated distraction of dorsal spines and spinal cord contusion (5). Also note signal hyperintensity caused by bone marrow edema in vertebral bodies of C6 and T1.

Figures 7 and 8 show ligamentous injury associated with a burst fracture of the cervical vertebrae. Figures 9–11 picture injuries caused by cervical hyperextension. Injuries associated with interfacetal dislocations and teardrop fractures are also shown in Figures 12–14.

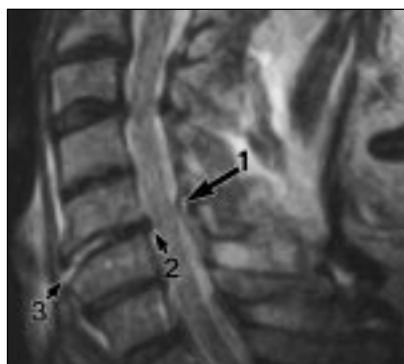
10

Fig. 10.—Hyperextension injury in 71-year-old man who fell from bicycle and presented with central cord syndrome. Sagittal T2-weighted MR image (TR/TE, 4500/117) obtained on 0.3-T MR scanner shows flaval ligament hypertrophy (1), C5-6 posterior disk protrusion (2), anterior longitudinal ligament tear, and partial disruption of C5-6 intervertebral disk (3).

column comprises the posterior vertebral body, the posterior longitudinal ligament, and the posterior annulus fibrosus. Hyperextension can result in injury to the anterior column (Fig. 10) or to both the anterior and middle columns (Figs. 11 and 15). The posterior column consists of the posterior ele-

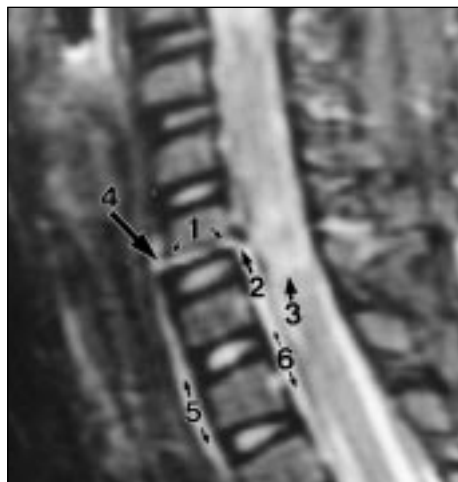
11

Fig. 11.—6-year-old boy with cervical spine hyperextension injury during motor vehicle crash. Sagittal fast spin-echo inversion-recovery MR image (TR/TE, 3000/51; inversion time, 140 msec) obtained on 1.5-T MR scanner shows horizontal fracture through inferior endplate of C6 (1), posterior longitudinal ligament tear (2), cord contusion (3), anterior longitudinal ligament tear (4), prevertebral hemorrhage or edema (5), and extradural hemorrhage (6). MR imaging findings guided therapy resulting in anterior surgical fusion.

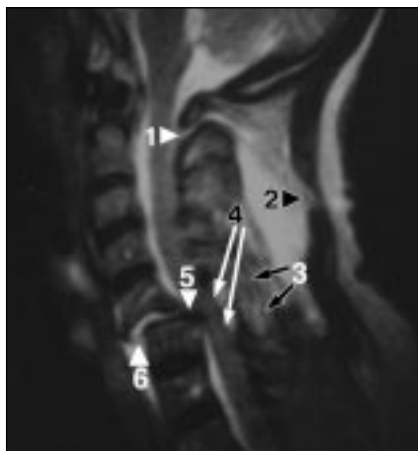
Fig. 13.—Bilateral interfacetal dislocation in 42-year-old woman involved in motor vehicle crash. Sagittal T2-weighted MR image (TR/TE, 4500/117) obtained on 0.3-T MR scanner shows tear of dura and posterior atlantoaxial membrane (1), partial tear of nuchal ligament (2), distraction of C5-6 spinous process and torn interspinous ligaments (3), torn flaval ligaments (4), torn posterior longitudinal ligament (5), and torn anterior longitudinal ligament (6).

ments of the spine, ligamentum flavum, interspinous ligaments, supraspinous ligaments, and facet joint capsules. Hyperflexion may result in injury to the middle and posterior columns (Figs. 9 and 16). Injury to any two adjacent columns will result in instability. Disruption of all three osseous or ligamentous supporting columns is shown in association with burst fractures in Figures 7 and 8, bilateral interfacetal dislocation is shown in Figures 12 and 13, and teardrop fractures of C7 are shown in Figure 14.

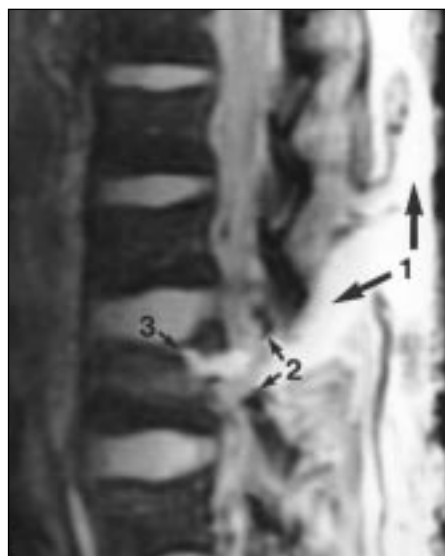
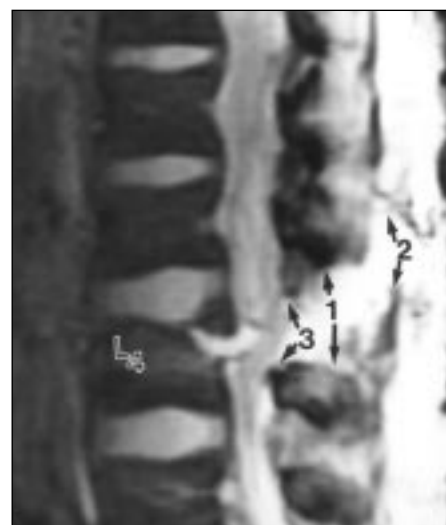
Fig. 16.—11-year-old boy who suffered flexion–distraction injury from lap belt during motor vehicle crash with fractures at L4 level.

A. Sagittal gradient-echo MR image (TR/TE, 500/13; flip angle, 15°) obtained on 1.5-T MR scanner shows large presumed cerebrospinal fluid leak into posterior subcutaneous tissues (1), distracted fracture fragments of left L4 articular processes (similar fracture was also present on right) (2), and distracted fracture, near horizontal in orientation, involving posterosuperior portion of L4 vertebral body (3).

B. Sagittal gradient-echo MR image (500/13; flip angle, 15°) obtained on 1.5-T MR scanner of midline shows distraction of spinous process of L3 and L4 (1), supraspinous ligament tear (2), and flaval ligament tear (3).
