# Pictorial Essay

## Sonography and Radiography of Soft-Tissue Foreign Bodies

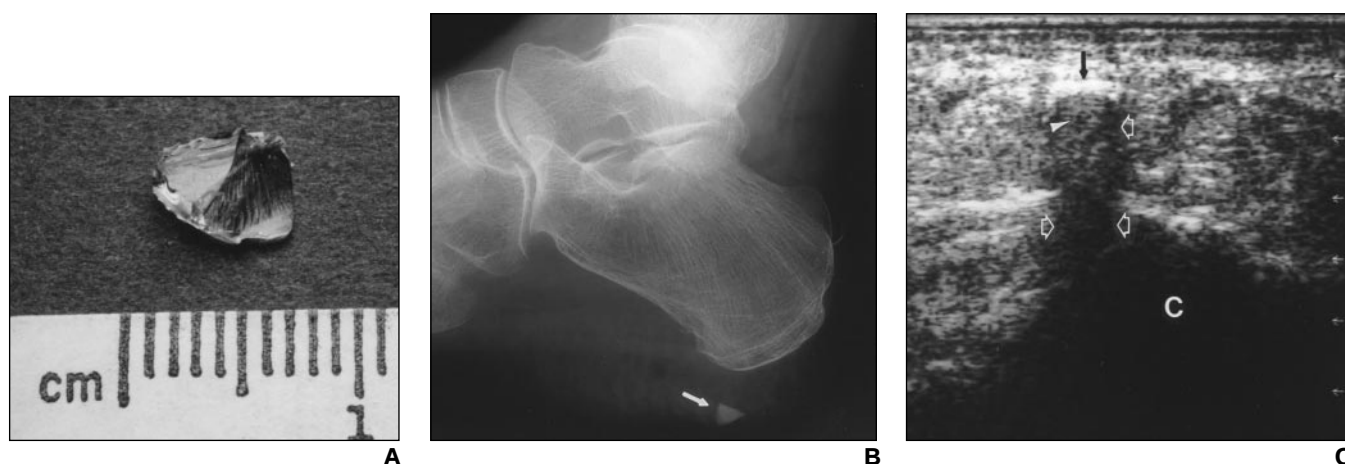
**Fig. 1.**—Windshield glass from automobile.

**A,** Photograph shows 5-mm glass fragment before being placed in cadaveric foot.

**B,** Lateral foot radiograph shows radiopaque glass fragment (*arrow*).

**C,** Sonogram of plantar surface of foot reveals hyperechoic glass fragment (*solid arrow*). Note posterior acoustic shadowing (*open arrows*) and reverberation (*arrowhead*). C = calcaneus.

A 5-mm fragment of glass from a domestic automobile was examined (Fig. 1A). On

radiography, the glass appeared radiopaque (Fig. 1B). On sonography, the glass appeared hyperechoic with posterior shadowing intermixed with a small amount of reverberation artifact (Fig. 1C).

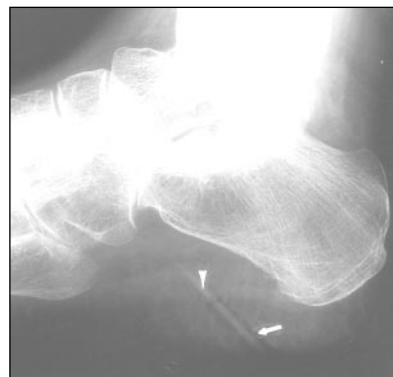
**Fig. 4.**—Wood and graphite pencil.  
**A,** Photograph shows 4-cm pencil fragment before being placed in cadaveric foot.  
**B,** Lateral foot radiograph shows pencil as centrally radiopaque, which represents graphite (*arrowhead*). Surrounding lucency represents wood (*arrow*).  
**C,** Sonogram of plantar surface of foot reveals hyperechoic pencil (in long axis) (*solid arrows*). Note complete posterior shadowing (*open arrows*).

A fragment from a standard #2 pencil containing wood and graphite was examined (Fig. 4A). On radiography, the 4-cm fragment appeared centrally radiopaque, which represented the graphite, surrounded by the more radiolucent wood (Fig. 4B). On sonography,

the pencil was hyperechoic and showed complete posterior shadowing (Fig. 4C).

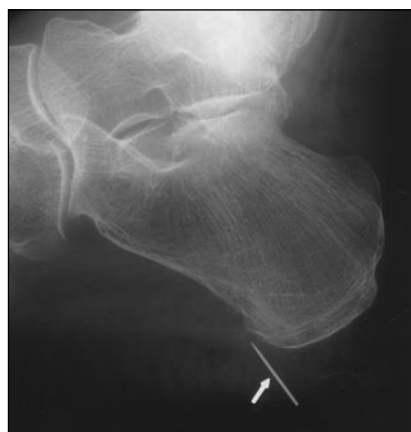
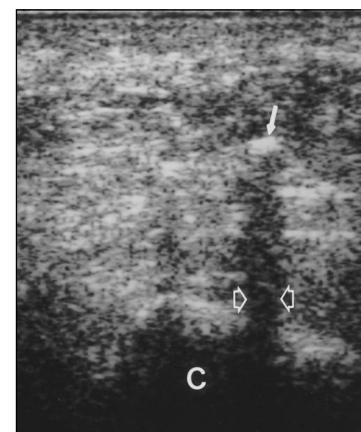
**Fig. 5.**—Metal sewing needle.  
**A,** Photograph shows 15-mm metal sewing needle before being placed in cadaveric foot.  
**B,** Lateral foot radiograph shows radiopaque needle (*arrow*).  
**C,** Sonogram of plantar surface of foot reveals hyperechoic needle (in short axis) (*solid arrow*). Note posterior acoustic shadowing (*open arrows*). C = calcaneus.

A 15-mm metal sewing needle was examined (Fig. 5A). On radiography, the needle appeared opaque (Fig. 5B). On sonography, the small diameter of the needle made it difficult to identify; however, a bright echo could be seen on close scrutiny

(Fig. 5C). Posterior acoustic shadowing further aided in localization of the echogenic needle.

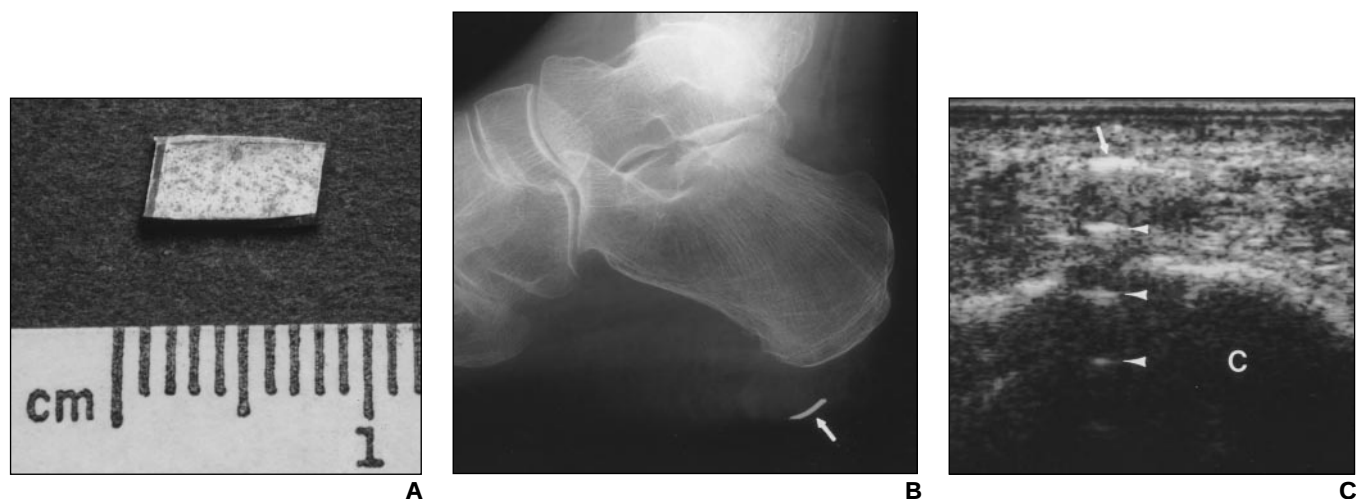
**Fig. 6.**—Galvanized steel fragment.

**A,** Photograph shows 3 × 7 mm galvanized steel fragment before being placed in cadaveric foot.

**B,** Lateral foot radiograph shows radiopaque steel foreign body (*arrow*).

**C,** Sonogram of plantar surface of foot reveals hyperechoic galvanized steel (*arrow*). Note posterior reverberation artifacts (*arrowheads*).

A 3 × 7 mm piece of 28-gauge galvanized steel was obtained from a pipe of a forced-air heating system (Fig. 6A). On radiography, it appeared radiopaque (Fig. 6B). On sonography, a bright linear echo was revealed with

posterior reverberation artifact caused by its smooth surface (Fig. 6C).

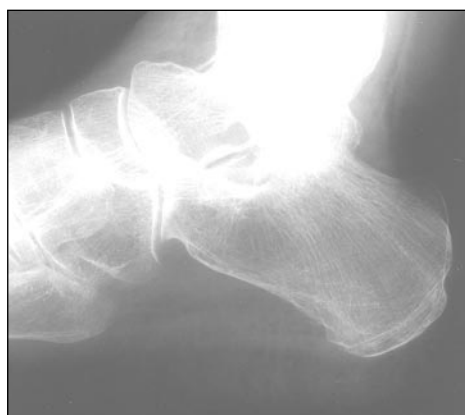
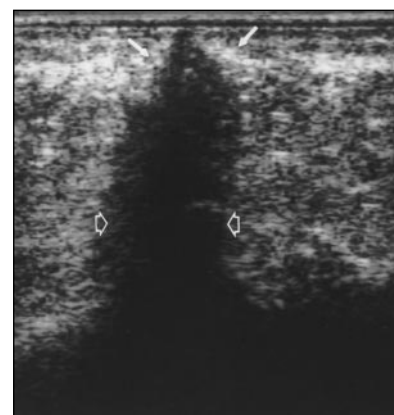
**Fig. 9.—Plastic.**

**A**, Photograph shows 15 × 6 mm plastic fragment before being placed in cadaveric foot.

**B**, Lateral foot radiograph does not show plastic foreign body.

**C**, Sonogram of plantar surface of foot reveals hyperechoic plastic foreign body (solid arrows). Note marked posterior shadowing (open arrows).

A 15 × 6 mm fragment of plastic from an automobile radio was examined (Fig. 9A). The plastic was not identifiable on radiography (Fig. 9B). On sonography, the plastic was less echogenic than the other foreign bodies studied, which may have been a result of its orientation not being perpendicular to the transducer beam (Fig. 9C). The plastic foreign body also showed marked posterior acoustic shadowing, which assisted in localization of the plastic fragment.
