Magnetic Resonance Imaging After Total Hip Arthroplasty: Evaluation of Periprosthetic Soft Tissue

Investigation performed at the Division of Magnetic Resonance Imaging and the Department of Orthopaedic Surgery, Hospital for Special Surgery, New York, NY

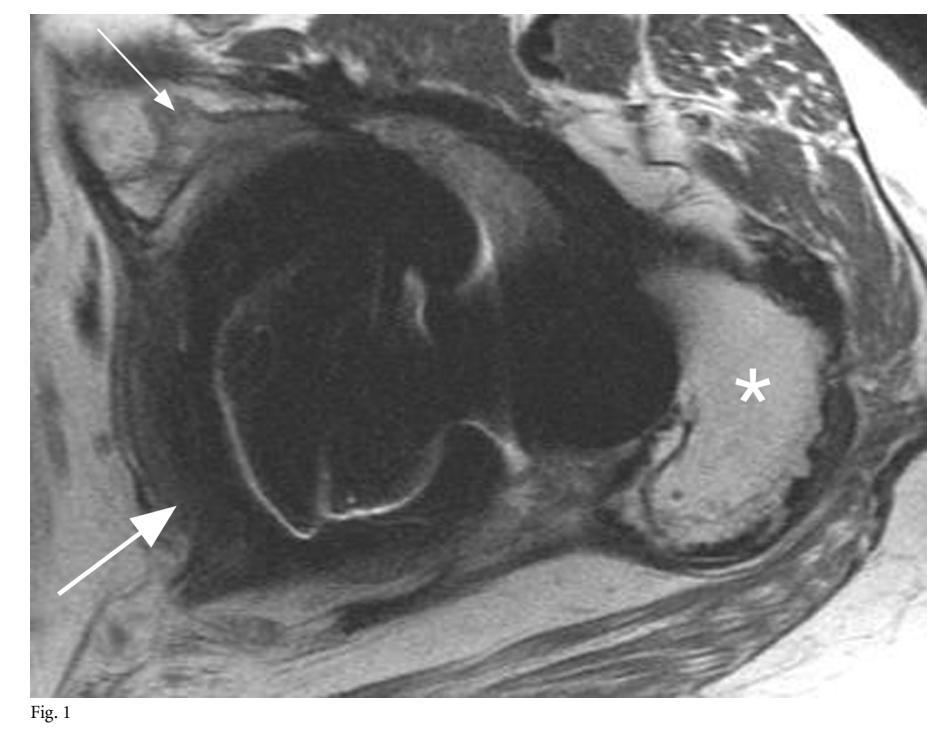
Axial fast-spin-echo magnetic resonance image of the hip of a seventy-one-year-old woman, obtained fourteen years after total hip arthroplasty, showing well-defined foci of marrow replacement in the medial wall (thick arrow), and in the anterior column (thin arrow). For orientation purposes, the greater trochanter is shown on the right (asterisk). Note the sharp contrast between the intermediate signal intensity of the osteolysis (similar to that of skeletal muscle) and the adjacent higher signal intensity of the fatty marrow. The pseudocapsule is distended anteriorly by material with the same signal characteristics.

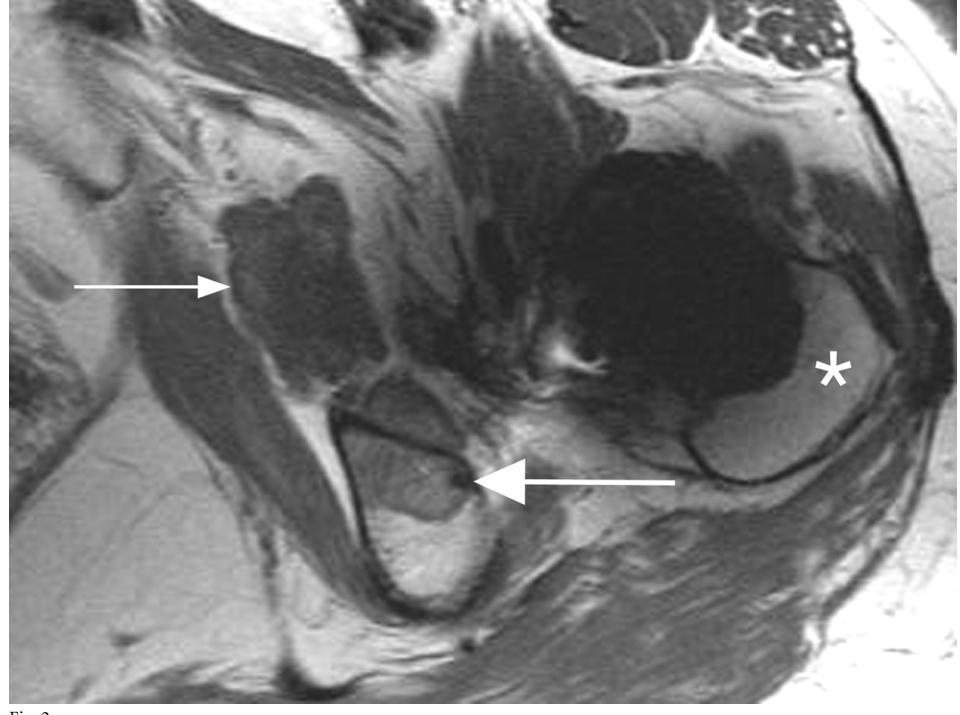
Axial fast-spin-echo magnetic resonance image of the hip of a sixty-nine-year-old woman, showing a soft-tissue mass of intermediate signal intensity (thin arrow). The signal intensity of this soft-tissue mass is the same as that of the osteolysis replacing the posterior margin of the ischium (thick arrow). For orientation purposes, the greater trochanter is shown on the right (asterisk). Note the low-signal-intensity rim outlining the focus of marrow replacement.

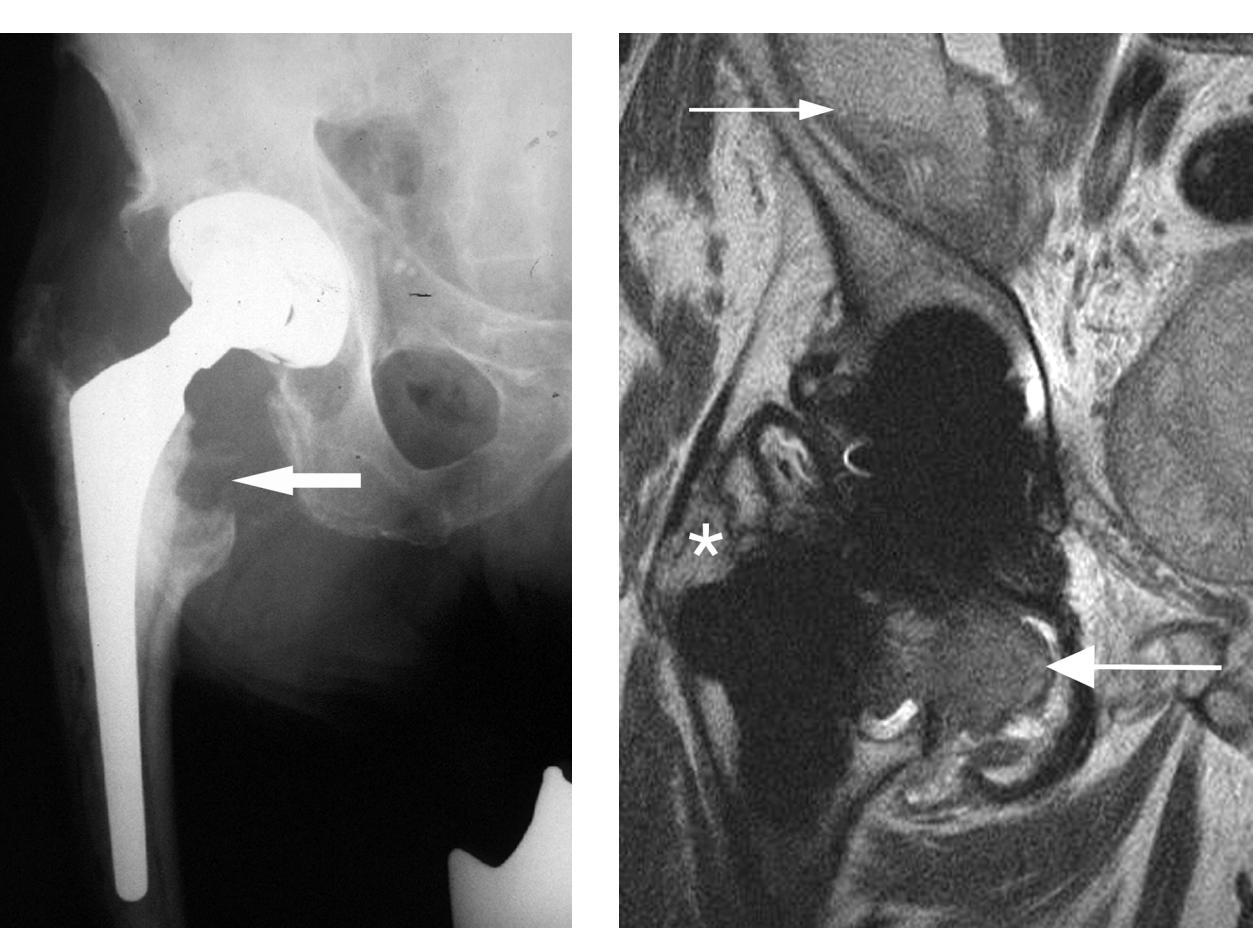
Fig. 3-A Plain radiograph of the hip of a seventy-two-year-old man, obtained 10.5 years after total joint arthroplasty, showing evidence of osteolysis. The prominent erosion of the medial portion of the femoral neck (arrow) raised the clinical concern of a superimposed tumor.
Fig. 3-B Subsequent coronal magnetic resonance image of the same hip shown in Figure 3-A, demonstrating massive osteolysis (thick arrow) replacing the normal high signal intensity of the marrow. For orientation purposes, the greater trochanter is shown on the left (asterisk). Note the additional involvement at the acetabular dome and the extension into the iliacus bursa (thin arrow). Also note that the osteolysis is well defined and is of intermediate signal intensity with a low-signal-intensity rim, indicating an indolent pattern of bone destruction that is atypical of tumors. The extent of osteolysis seen on radiographs did not reflect the severe degree of osteolysis seen on magnetic resonance imaging, which aided in the planning for revision arthroplasty and removed any concern regarding the presence of a neoplasm.

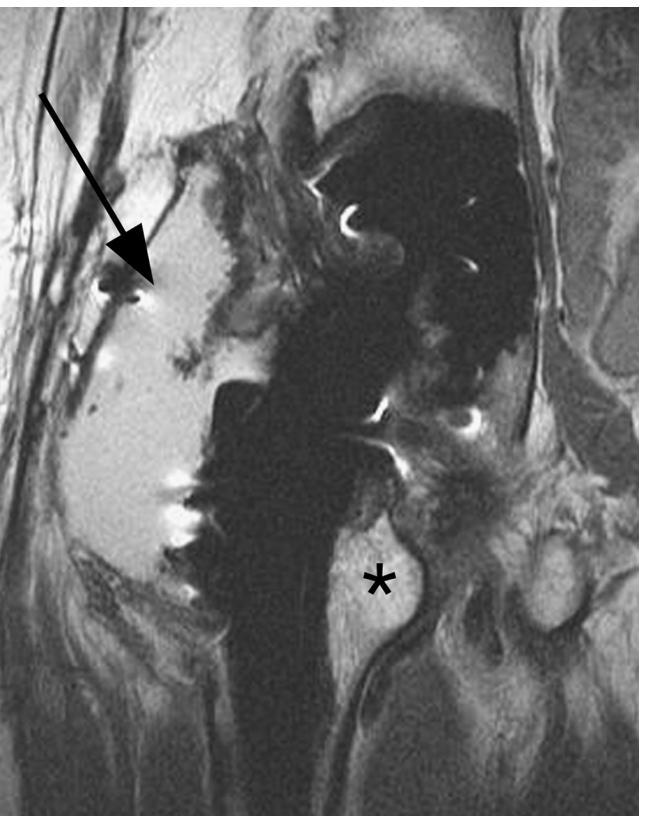
Fig. 4

Coronal fast-spin-echo magnetic resonance image of the hip of a sixty-seven-year-old woman who presented with pain twenty-four years after primary arthroplasty, demonstrating a large fluid collection (arrow) lined by metallic debris in the greater trochanteric bursa lateral to the site of the arthroplasty. For orientation purposes, the lesser trochanter is shown on the lower right (asterisk).

Twenty-five of the twenty-eight hips had distention of the normally thin, hypointense pseudocapsule by particulate synovitis. The intracapsular debris typically had signal characteristics that were similar to those of the material replacing the bone; the only exception was noted in one hip, in which metallic debris was seen. The implant in that hip had a titanium stem and a titanium acetabular component that articulated with a cobalt-chromium head (Fig. 4).

to the neurovascular bundles and joint. Foci of mature heterotopic ossification are denoted as foci of discrete fatty marrow signal intensity in the adjacent soft tissues, often with no discernible tissue plane adjacent to the implant²¹. Two patients demonstrated an insufficiency fracture of the hemisacrum and pubic ramus (one patient) or the sacral ala (one patient). Two hips demonstrated moderate greater trochanteric bursitis as evidenced by the presence of a discrete, characteristic fluid collection at that site²². One examination demonstrated osteolysis and diminished signal intensity throughout the synovial lining and adjacent bursae, indicating an extensive debris load (Fig. 4).

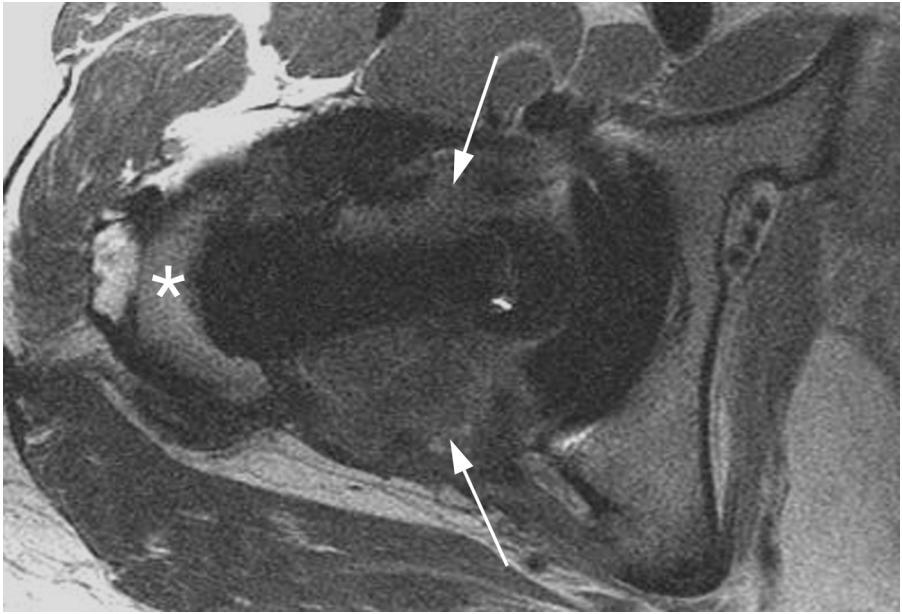
Axial fast-spin-echo magnetic resonance image of the hip of a forty-five-year-old man who presented, one year after total hip arthroplasty, with posterior dislocation despite acceptable component alignment on plain radiographs. For orientation purposes, the greater trochanter is shown on the left (asterisk). The image demonstrates marked distention of the pseudocapsule, which is filled with diminished-signal-intensity debris (arrows), that was attributed to particle reaction, without concomitant osteolysis. These findings were confirmed at the time of revision arthroplasty.
