Malrotation Causing Patellofemoral Complications After Total Knee Arthroplasty

R.A. Berger, MD *; L.S. Crossett, MD**; J.J. Jacobs, MD *; and H.E. Rubash, MD⁺

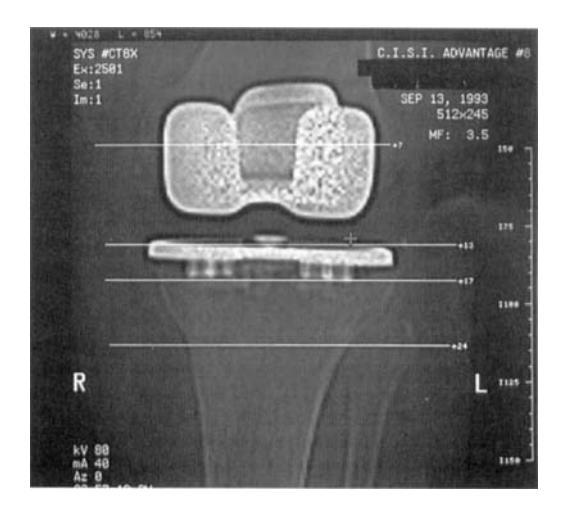
Fig 1. The anteroposterior scout view obtained in the CT scanner. The scans are perpendicular to the mechanical axis of the knee. Images of 1.5 mm in thickness were obtained through the epicondylar axis on the femur (Line +7), through the tibial tubercle (Line +24), through the top of the tibial plateau (Line +17), and through the tibial component (Line +13). R = right; L = left. **Fig 2.** The lateral scout view obtained in the CT scanner. The scans were taken perpendicular to the long axis of the femur for the femoral cut and perpendicular to the long axis of the tibia for the tibial cuts. This is achieved by tilting the scanner's gantry. As in Figure 1, 1.5-mm thick images were obtained through the epicondylar axis on the femur (Line +7), through the tibial tubercle (line +24), through the top of the tibial plateau (Line +17), and through the tibial component (Line +13).

Preoperative CT scans were obtained to determine the rotation of the tibial and femoral components. This technique is applicable to any CT scanner. The patient was placed supine on the CT scanning table with the involved extremity in full extension with the extremity adjusted to allow the scans to be perpendicular to the mechanical axis of the knee (Fig 1). Using the lateral scout view, the scans were taken perpendicular to the long axis of the femur for the femoral scan and perpendicular to the long axis of the tibia for the tibial scans (Fig 2). This was achieved by tilting the scanner's gantry. Computed tomographic images 1.5 mm in thickness were obtained at four locations: through the epicondylar axis on the femur, though the tibial tubercle, through the top of the tibial plateau, and through the tibial component (Figs 1, 2).

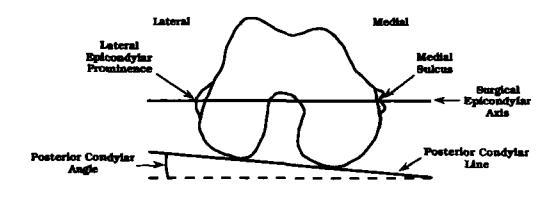
Fig 3. Line drawing of the cross section of the femur through the epicondylar axis. The surgical epicondylar axis connects the lateral epicondylar prominence and the medial sulcus of the medial epicondyle. The posterior condylar line connects the medial and lateral posterior condylar surfaces. The posterior condylar angle is the angular measurement subtended by these two lines. (Reprinted and adapted with permission from Berger RA, Rubash HE, Seel MJ, Thompson WH, Crossett LS: Determining the rotational alignment of the femoral component in total knee arthroplasty using the epicondylar axis. Clin Orthop 286:40–47, 1993.)

The rotation of the femoral component was determined using the single axial CT image through the femoral epicondyles² (Fig 3). On this CT image, two lines are drawn (Fig 4). The first line, the surgical epicondylar axis, connects the lateral epicondylar prominence and the medial sulcus of the medial epicondyle.² The second line, the prosthetic posterior condylar line, connects the medial and lateral prosthetic posterior condylar surfaces.² The angle subtended by these two lines, the prosthetic posterior condylar angle, then was measured.

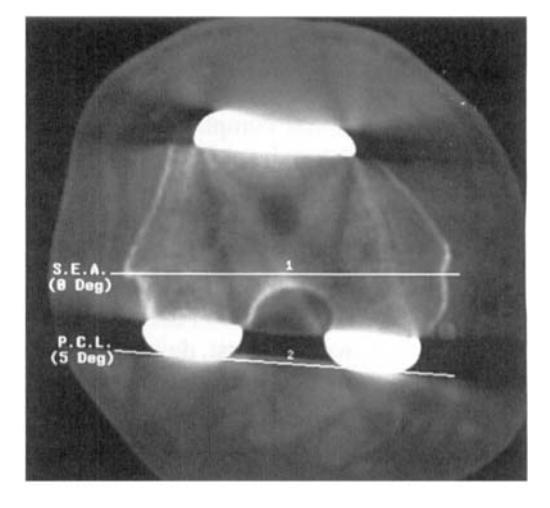
Fig 4. Axial CT image of the right femur through the epicondylar axis (Line +7 on the scout views shown in Figures 1 and 2). Compare this view with Figure 3. The surgical epicondylar axis (S.E.A.) connects the lateral epicondylar prominence and the medial sulcus of the medial epicondyle. The posterior condylar line (P.C.L.) connects the medial and lateral prosthetic posterior condylar surfaces. Deg = degrees.

Figure 4 shows the right knee of a female patient. First, the surgical epicondylar axis (S.E.A.) is shown connecting the lateral epicondylar prominence and the medial sulcus of the medial epicondyle. This line is positioned 0° to the horizontal. Second, the prosthetic posterior condylar line (P.C.L.) is shown connecting the medial and lateral prosthetic posterior condylar surfaces. This is positioned 5° (internal) to the horizon. The angle between these two lines is 5°. This indicates that the femoral component is 5° internally rotated relative to the surgical epicondylar axis. In females the normal posterior condylar angle is $0.3^{\circ} (\pm 1.2^{\circ})$ internal rotation; therefore, the femoral component is in 4.7° excessive internal rotation as compared with the surgical epicondylar axis.

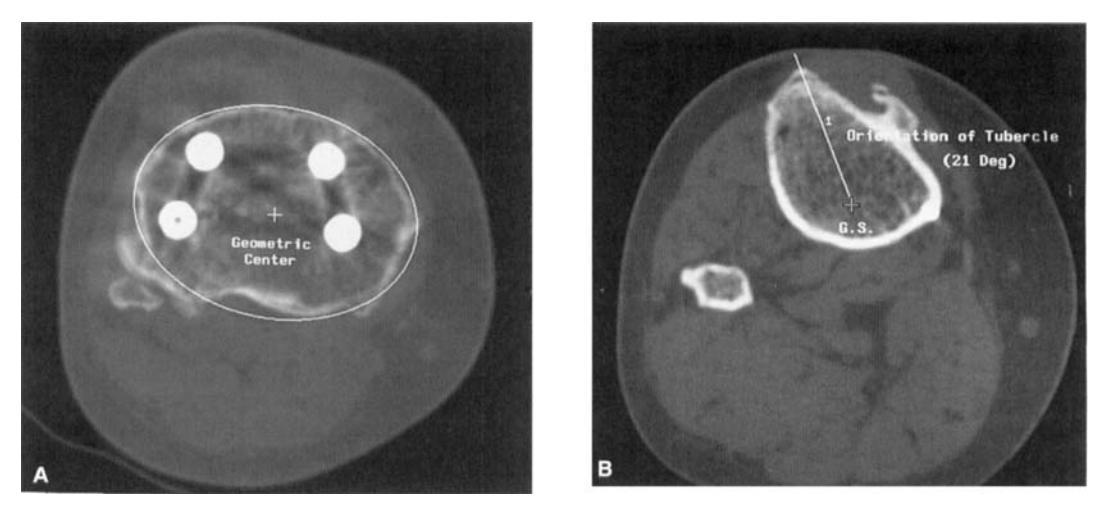
Fig 5A–B. (A) Axial CT image through the proximal tibial plateau, just distal to the tibial plateau. The CT scanner oval that is sized and rotated to best fix the proximal plateau is shown. The center of the oval is marked automatically by the computer. (B) Axial CT image through the tip of the tibial tubercle. The geometric center (G.S.) of the tibial plateau then was transposed distally to this image. The tibial tubercle orientation is defined by the line connecting the geometric center of the tibial plateau to the tip of the tibial tubercle. This line is at 21° external rotation (referenced to the vertical) as measured on the CT scan. Deg = degrees.

plateau was located (Fig 5A) and axially transposed distally to the level of the tibial tubercle (Fig 5B). Then the geometric center of proximal tibial plateau and the tip of the tubercle are connected giving the orientation of the tubercle (Fig 5B). The anteroposterior (AP) tibial component axis is drawn on the single axial scan through the tibial component (Fig 6A). The tibial component rotation is subtended by the orientation of the tibial tubercle and the AP tibial component axis³ (Fig 6B).

The geometric center of the tibial plateau obtained in Figure 5A is transposed to Figure 5B. In Figure 5B, a line connecting the geometric center (G.S.) to the tip of the tibial tubercle denotes the tibial tubercle axis. On Figure 6A, the AP tibial component axis (T.C.A.) is drawn perpendicular to the posterior surface of the component. Figure 6B shows the tibial component axis (T.C.A.) from Figure 6A with the superimposed orientation of the tibial tubercle axis from Figure 5B. This angle measures 23° internal rotation. The normal value for this angle is 18° . Therefore, the tibial component is in 5° excessive internal rotation.

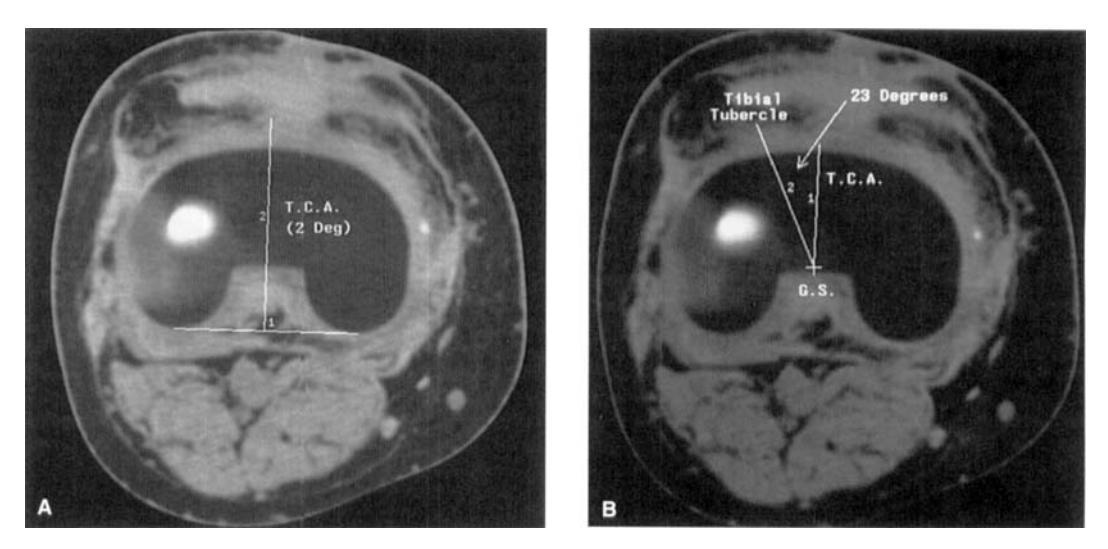
Fig 6A–B. (A) Axial CT image through the tibial component polyethylene. The tibial component axis (T.C.A.) was defined as the perpendicular (2) to the transverse axis of the tibial component (1). For this rectangular tibial component, the tibial component axis is perpendicular to the posterior margin of the component. This line is at 2° internal rotation (referenced from the vertical) as measured on the CT scan. Deg = degrees. (B) Axial CT image through the tibial component polyethylene. The tibial tubercle orientation from Figure 5A is superimposed on the tibial component axis (T.C.A.) from Figure 6A. The rotation of the tibial component is recorded as the angle subtended by the tibial tubercle axis (2) and the tibial component axis (T.C.A.) (1). The difference is 23°, indicating the rotation of the tibial component is 23° internal rotation relative to the tibial tubercle.

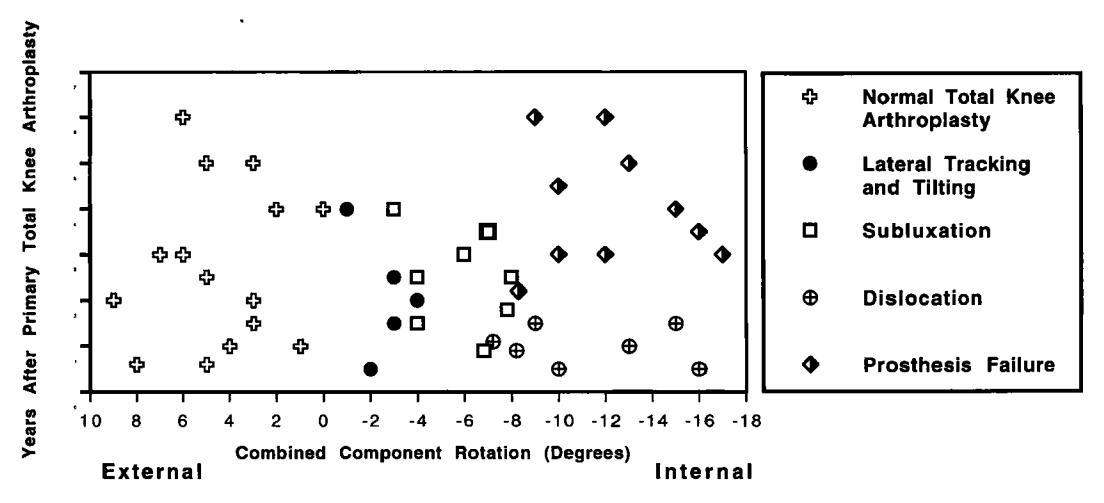
Fig 7. Graph showing the relationship of combined component rotation to the time that each patient first had patellofemoral complications develop. Thirty patients with isolated patellofemoral complications after total knee arthroplasty are in combined excessive internal rotation. These 30 patients are clustered into four groups by type of patellofemoral complication. In addition, severity of the patellofemoral complication increases with increasing combined excessive internal rotation. The control group of 20 well functioning total knee replacements without patellofemoral complications are in combined excessive external rotation.
